**TEST REPORT**

**REPORT No:** SV30563-20160311-Report

LIVEWALL, LLC  
Spring Lake , MI

**Criteria For Testing Impact & Nonimpact Resistant Building Envelope Components Using  
Uniform Static Air Pressure (Structural Only)**

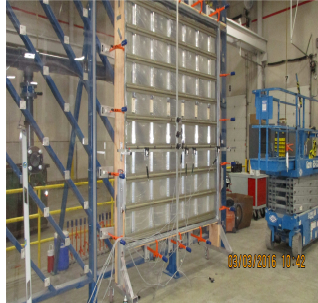
**Exterior view of specimen**

Specimen #	Test Specimen Description
Specimen #1, 2, 3	<p>The test assembly consisted of an extruded aluminum framing irrigation system to be anchored to the building envelope.</p> <p>The entire unit measured approximately 82 1/8" wide x 99" high, with the entire unit being comprised of an upper and lower unit, the upper unit measuring 82 1/8" X 40 7/8" and approximately a 7 inch gap and then a 82 1/8" X 51-1/2" lower unit with the Vetirail oriented 180 degrees to the opposite direction. The specimen was bagged with plastic sheets in between the wooden frame and the specimen and duct taped and spray adhesive was used to make an airtight seal to allow pressure to build and act upon the specimen.</p>

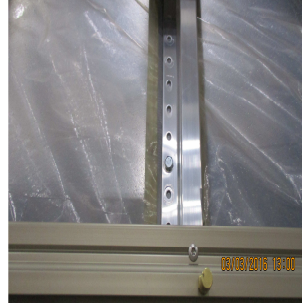
**View of installation  
anchors on specimen**

Specimen was installed onto a 100"X104" frame built with 4" by 4" pressure treated lumber secured with post strap ties between frame members. Each member was 16 inches apart with the right end member being 7' 1/2" and the left end member being 6-1/2" from the end. The testing unit was then installed onto the frame with 16 hex head 7/16 diameter by 1/4" by 1-1/2" threads set screws from Vetirail into wooden substrate nominally spaced 12 inches.

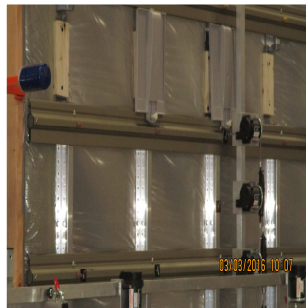
**Specimen prepared for  
structural load testing**

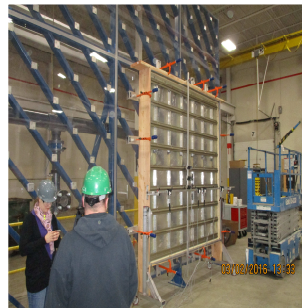
**Structural load testing  
conducted on specimen**

(Specimen was held for 30 seconds under load and then allowed a rest time of between 1 minute and 5 minutes, no deformation or noticeable destruction of the product occurred)

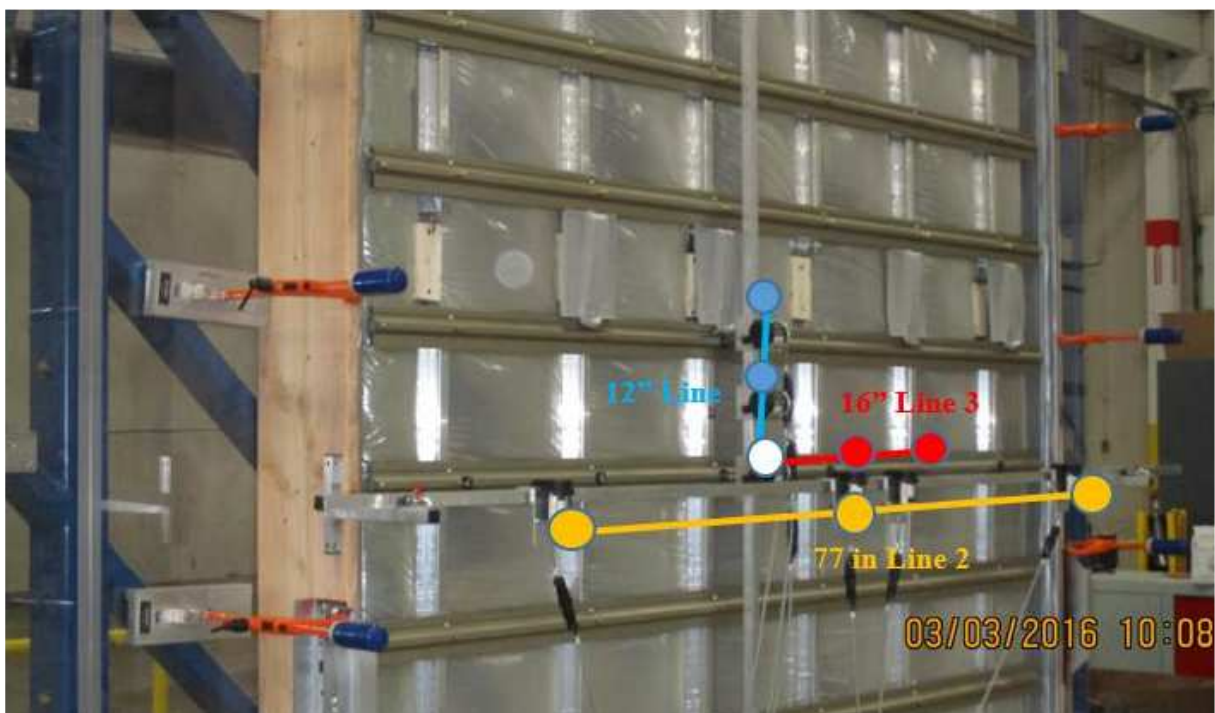
### Deflection Locations

<b>Line 1, 12 inch span</b>	Exterior Pressure (Positive)	Interior Pressure (Negative)
Design Pressure	<b>105.26 psf</b>	<b>105.26 psf</b>
Peak Deflection (30 sec)	0.013	0.079
Overload Pressure	<b>157.89 psf</b>	<b>157.89 psf</b>
Permanent Set (30 sec)	0.023	0.008
<b>Line 2, 77 inch span</b>	Exterior Pressure (Positive)	Interior Pressure (Negative)
Design Pressure	<b>105.26 psf</b>	<b>105.26 psf</b>
Peak Deflection (30 sec)	0.576	0.013
Overload Pressure	<b>157.89 psf</b>	<b>157.89 psf</b>
Permanent Set (30 sec)	0.13	0.008
<b>Line 3, 16 inch span</b>	Exterior Pressure (Positive)	Interior Pressure (Negative)
Design Pressure	<b>105.26 psf</b>	<b>105.26 psf</b>
Peak Deflection (30 sec)	0.023	0.002
Overload Pressure	<b>157.89 psf</b>	<b>157.89 psf</b>
Permanent Set (30 sec)	0.072	0.002

<b>Line 1, 12 inch span</b>	Exterior Pressure (Positive)	Interior Pressure (Negative)
Design Pressure	<b>105.26 psf</b>	<b>105.26 psf</b>
Peak Deflection (30 sec)	0.007	0.036
Overload Pressure	<b>157.89 psf</b>	<b>157.89 psf</b>
Permanent Set (30 sec)	0.001	0.000
<b>Line 2, 77 inch span</b>	Exterior Pressure (Positive)	Interior Pressure (Negative)
Design Pressure	<b>105.26 psf</b>	<b>105.26 psf</b>
Peak Deflection (30 sec)	0.596	0.69
Overload Pressure	<b>157.89 psf</b>	<b>157.89 psf</b>
Permanent Set (30 sec)	0.027	0.029
<b>Line 3, 16 inch span</b>	Exterior Pressure (Positive)	Interior Pressure (Negative)
Design Pressure	<b>105.26 psf</b>	<b>105.26 psf</b>
Peak Deflection (30 sec)	0.007	0.005
Overload Pressure	<b>157.89 psf</b>	<b>157.89 psf</b>
Permanent Set (30 sec)	0.001	0.001

<b>Line 1, 12 inch span</b>	Exterior Pressure (Positive)	Interior Pressure (Negative)
Design Pressure	<b>105.26 psf</b>	<b>105.26 psf</b>
Peak Deflection (30 sec)	0.004	0.001
Overload Pressure	<b>157.89 psf</b>	<b>157.89 psf</b>
Permanent Set (30 sec)	0.003	0.001
<b>Line 2, 77 inch span</b>	Exterior Pressure (Positive)	Interior Pressure (Negative)
Design Pressure	<b>105.26 psf</b>	<b>105.26 psf</b>
Peak Deflection (30 sec)	0.035	0.004
Overload Pressure	<b>157.89 psf</b>	<b>157.89 psf</b>
Permanent Set (30 sec)	0.006	0.009
<b>Line 3, 16 inch span</b>	Exterior Pressure (Positive)	Interior Pressure (Negative)
Design Pressure	<b>105.26 psf</b>	<b>105.26 psf</b>
Peak Deflection (30 sec)	0.003	0.002
Overload Pressure	<b>157.89 psf</b>	<b>157.89 psf</b>
Permanent Set (30 sec)	0.003	0.013
